CORRESPONDENCE FROM THE APPLICANT

RE; 1187 Coast Village Road, Montecito.

1187 Coast Village Road – Canary Island Pine Trees (*Pinus Canariensis*)

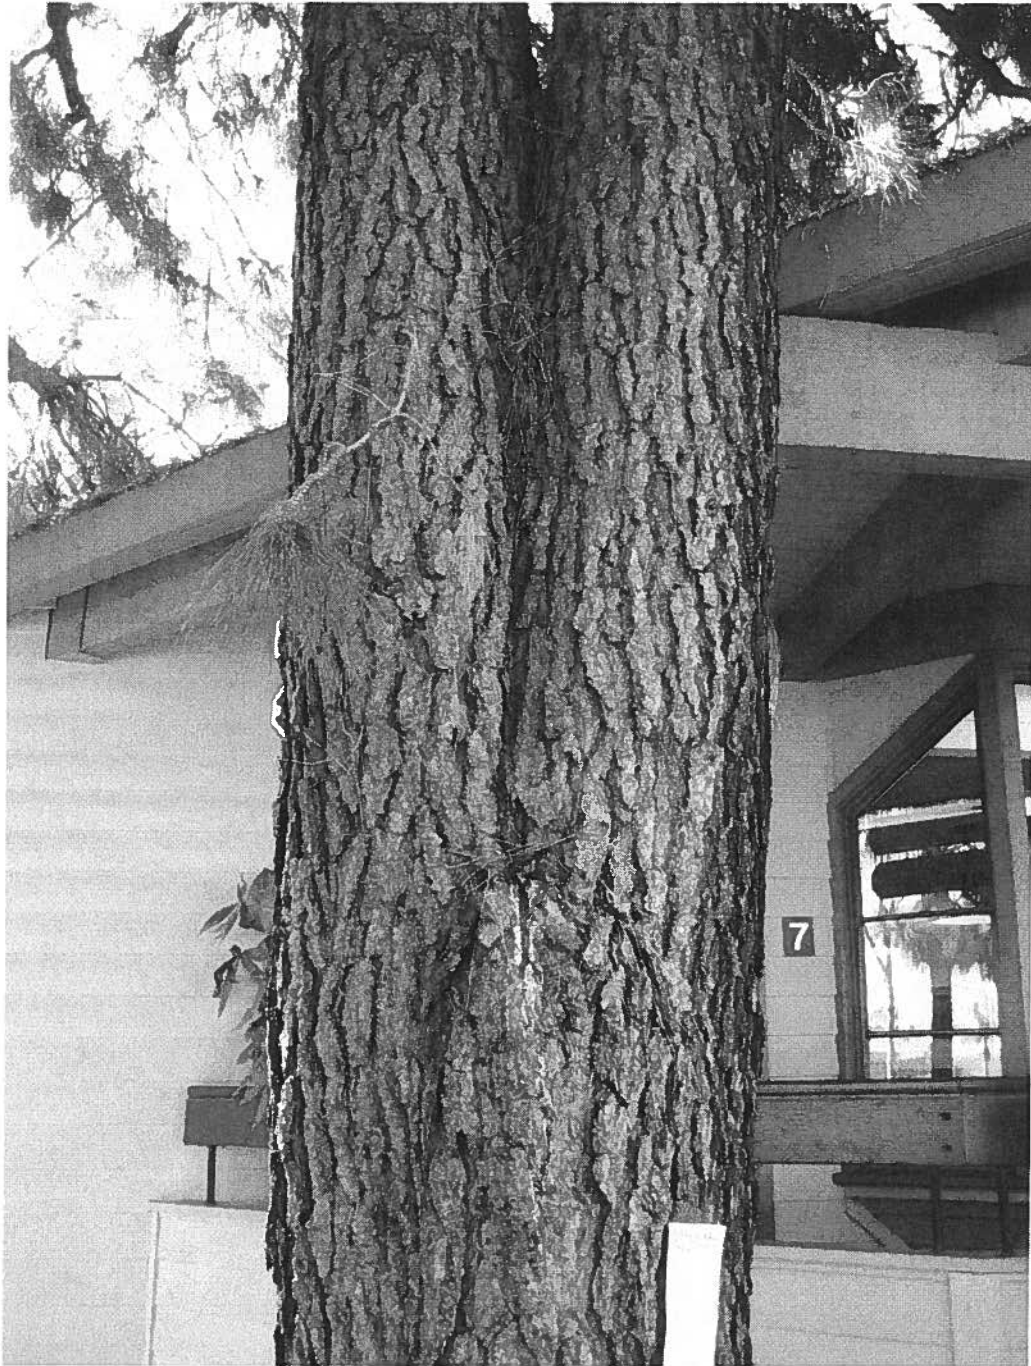
The other two 24" dbh Pines located on the northeast corner of the property adjacent to Coast Village Road are not good specimens due to structural imperfections. Superficially, as you glance at the trees that have formed one canopy they appear to be worthy skyline trees but upon closer examination I found this not to be the case. My primary concern is with the larger of the two trees closest to the building, it has two stems (commonly called codominant stems)

starting at about 6ft. Unfortunately, this is an extremely hazardous condition as the two stems have a tendency to split apart at any time and as the tree continues to grow and expand its trunk girth, there is a greater chance of failure. Given the surrounding target area of buildings, public streets, cars and pedestrians, I have to recommend its removal regardless of the any impact from the proposed project. Please see the attached site photographs, Attachment B.

Existing 24" dbh Canary Island Pine with co-dominant stems

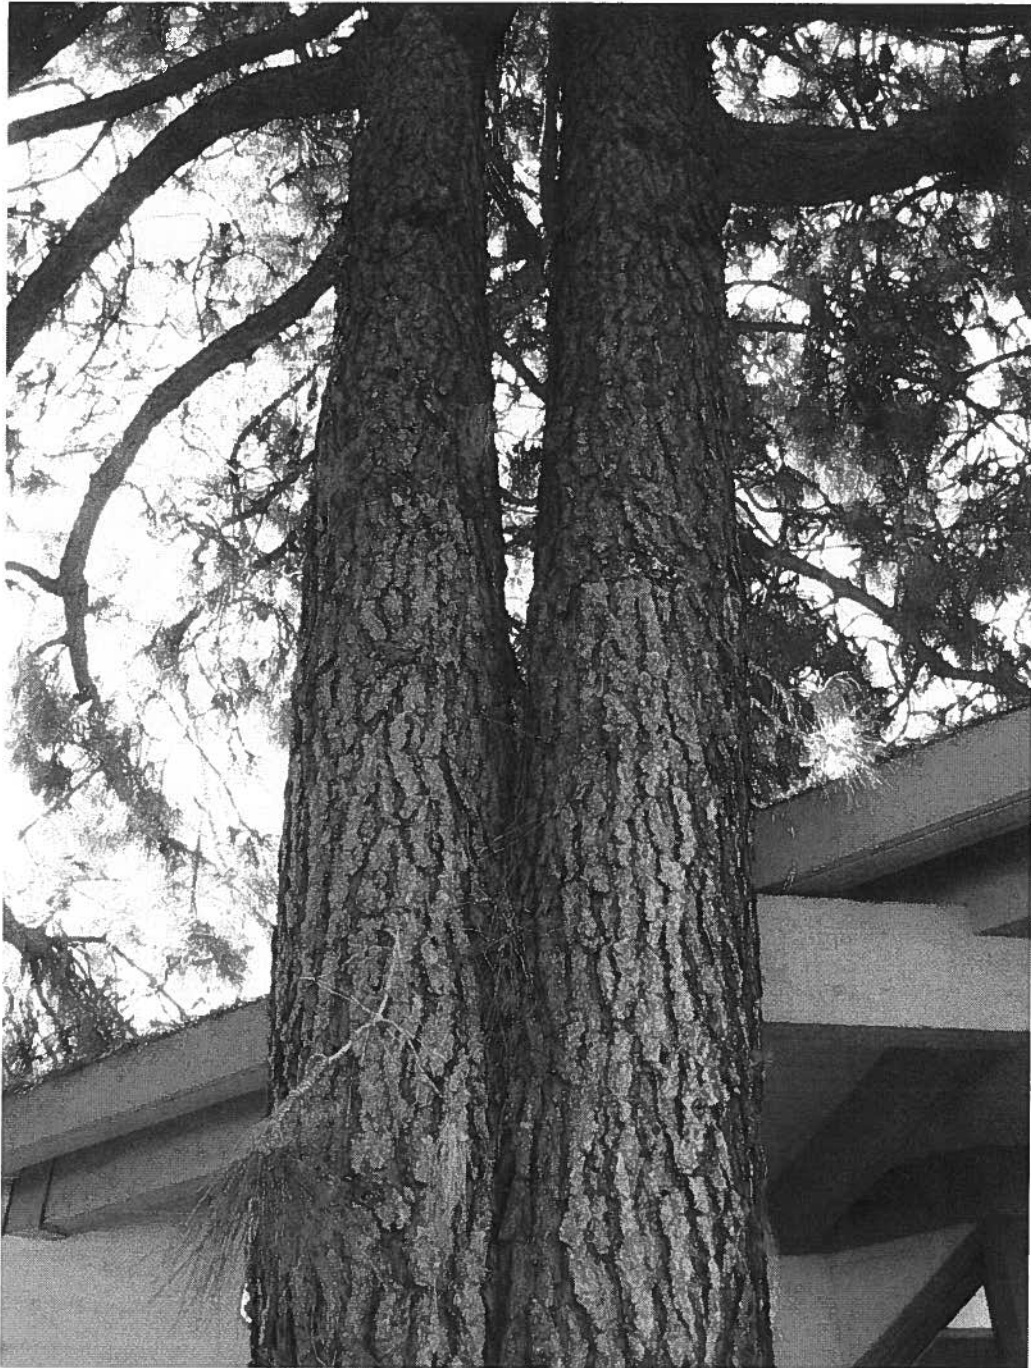
Existing 24" dbh Canary Island Pine with co-dominant stems

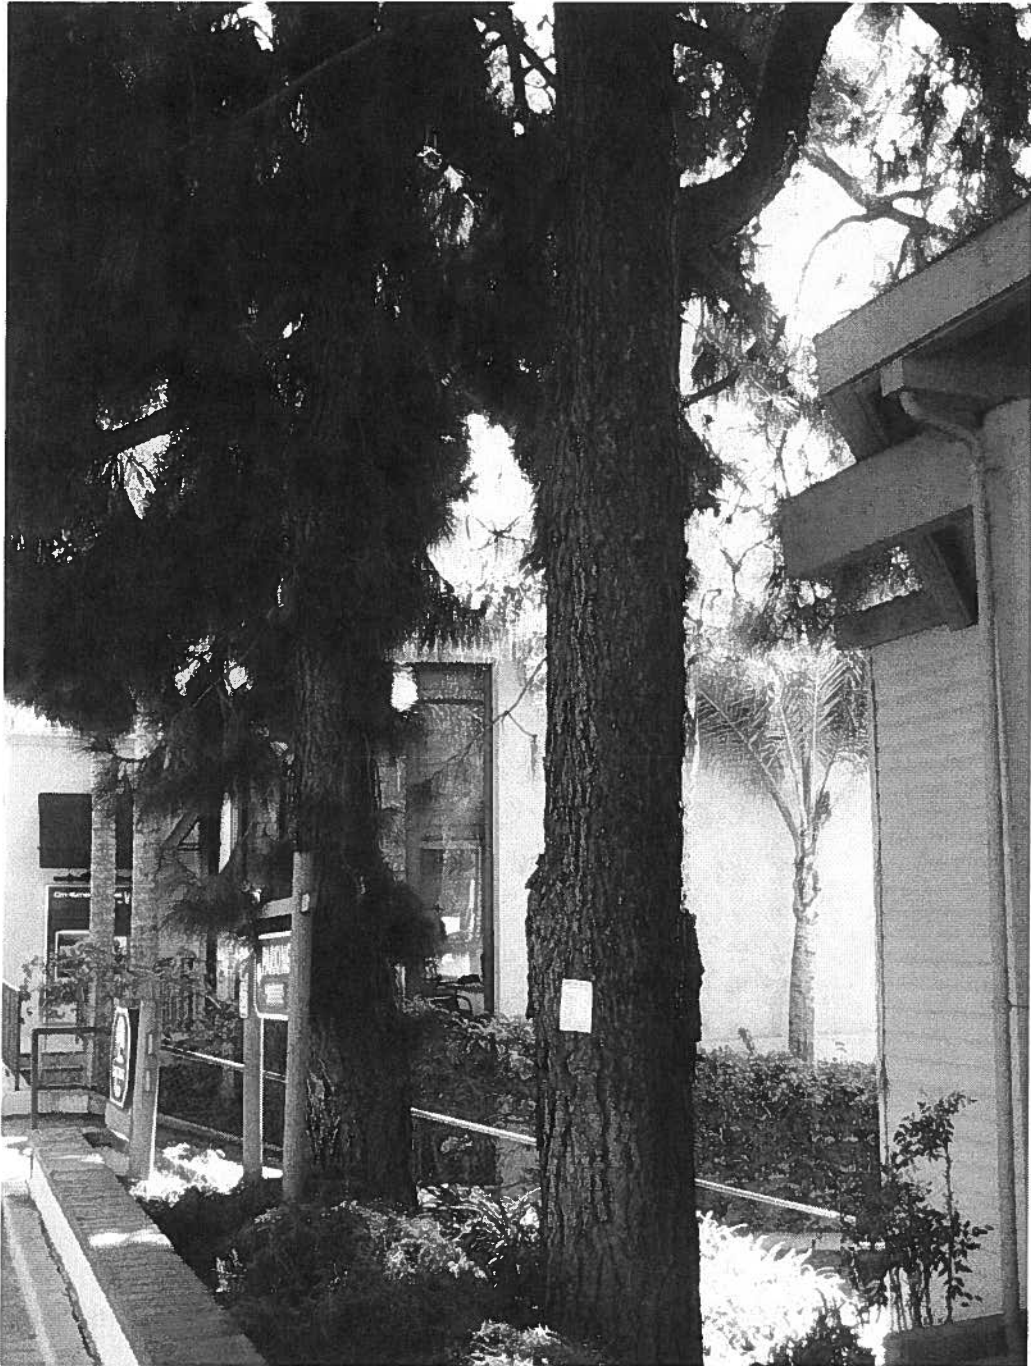
The remaining third 16" dbh Pine tree adjacent to the twin-stemmed Pine does have a lean to the east and all of its branches are on the east side of the tree due to being suppressed by its partner tree. Given I recommended the removal of the twin-stemmed tree, the remaining Pine will not only look out of place but will be susceptible to failure due to its weighted lean to the east and will be far more vulnerable to wind-throw. I feel it prudent to remove this tree also and replace with a new specimen tree in the same general location.

Existing 16" dbh and 24" dbh Canary Island Pines located on the northeast corner of the subject property

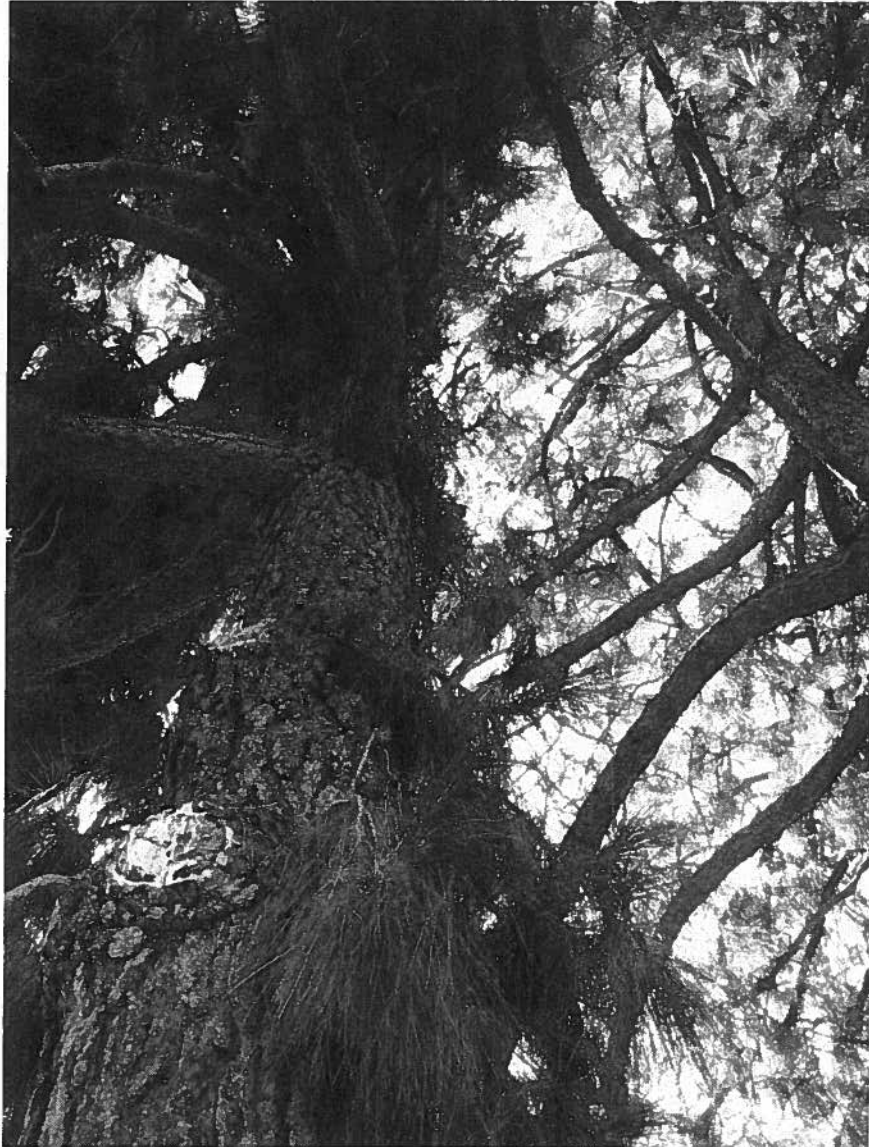
Existing 16" dbh and 24" dbh Canary Island Pines located on the northeast corner of the subject property

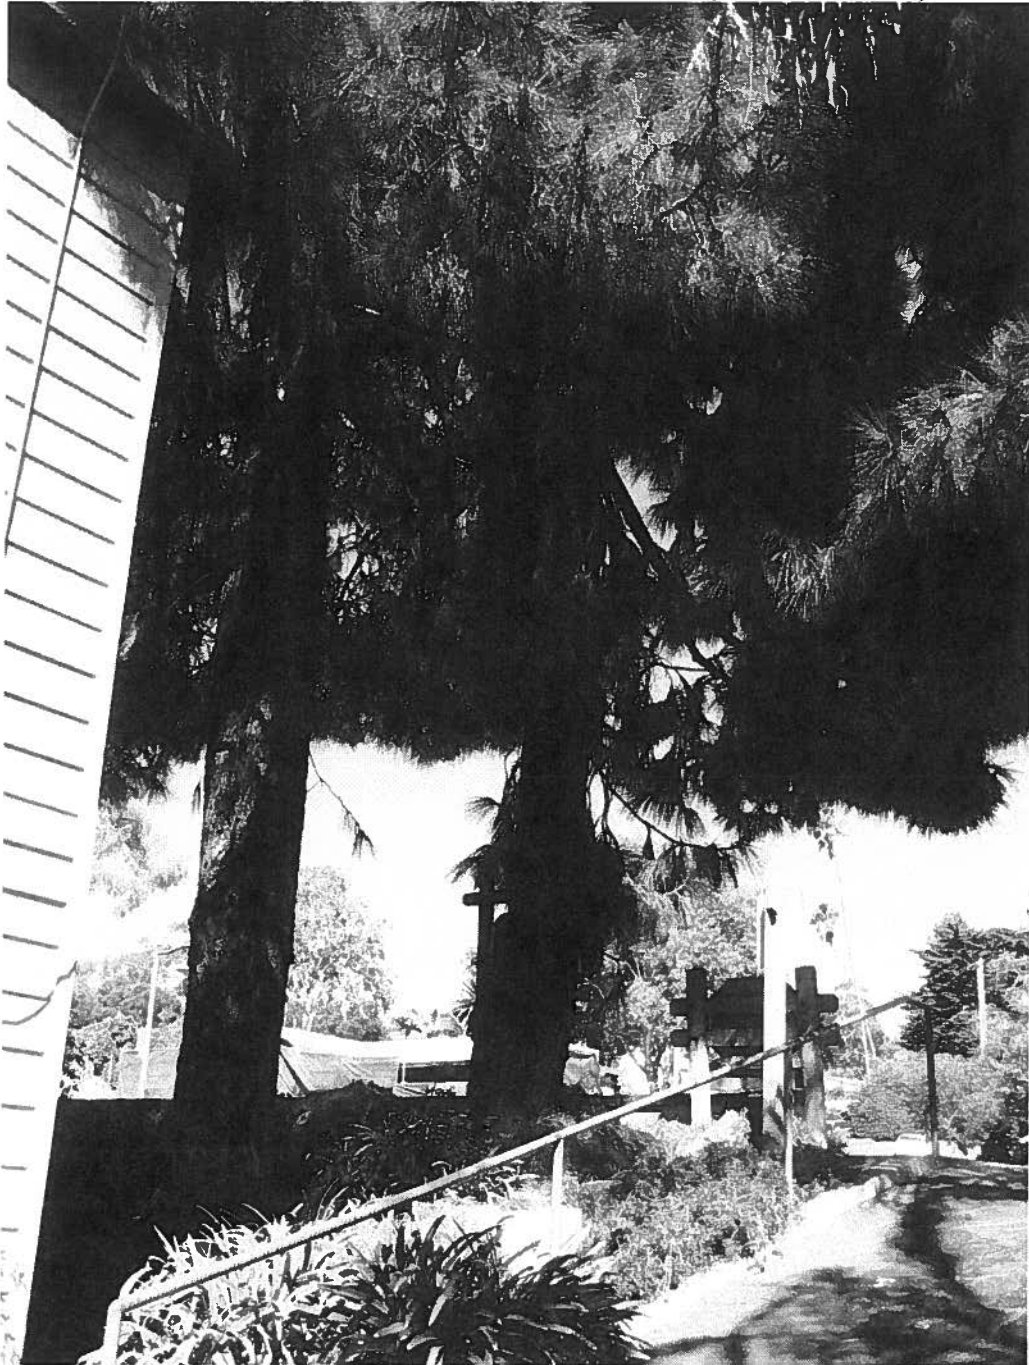
Existing 16" dbh and 24" dbh Canary Island Pines located on the northeast corner of the subject property
